BS EN 13823:2020

Reaction to Fire Tests for Building Products - Building Products Excluding Floorings Exposed to the Thermal Attack by a Single Burning Item

A Report To: Zenova Ltd

Document Reference: 500660

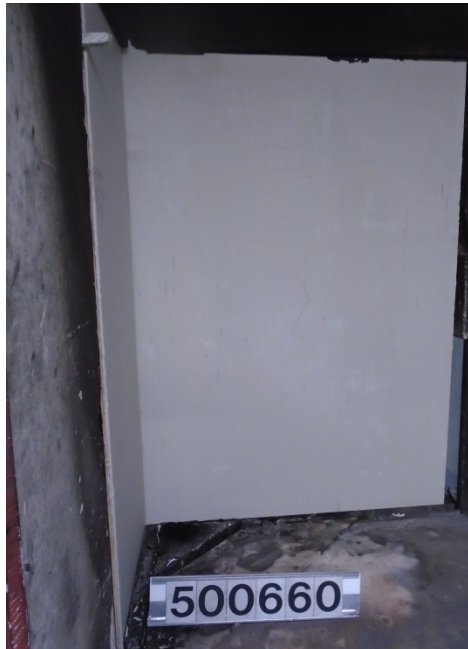
Plate 1: Total View of the exposed surface of the long wing.

Photographs of the installed product are appended as Plates 1 and 2 in Appendix 1 of this report.

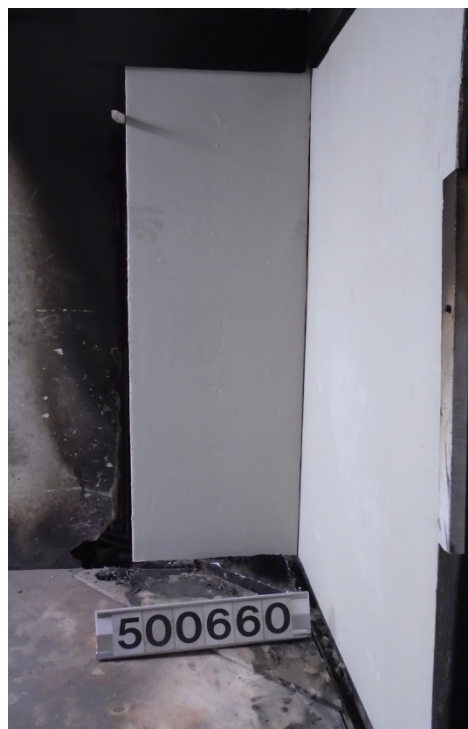
Plate 2: Close up view of the vertical outer edge of the long wing at a height of 500mm

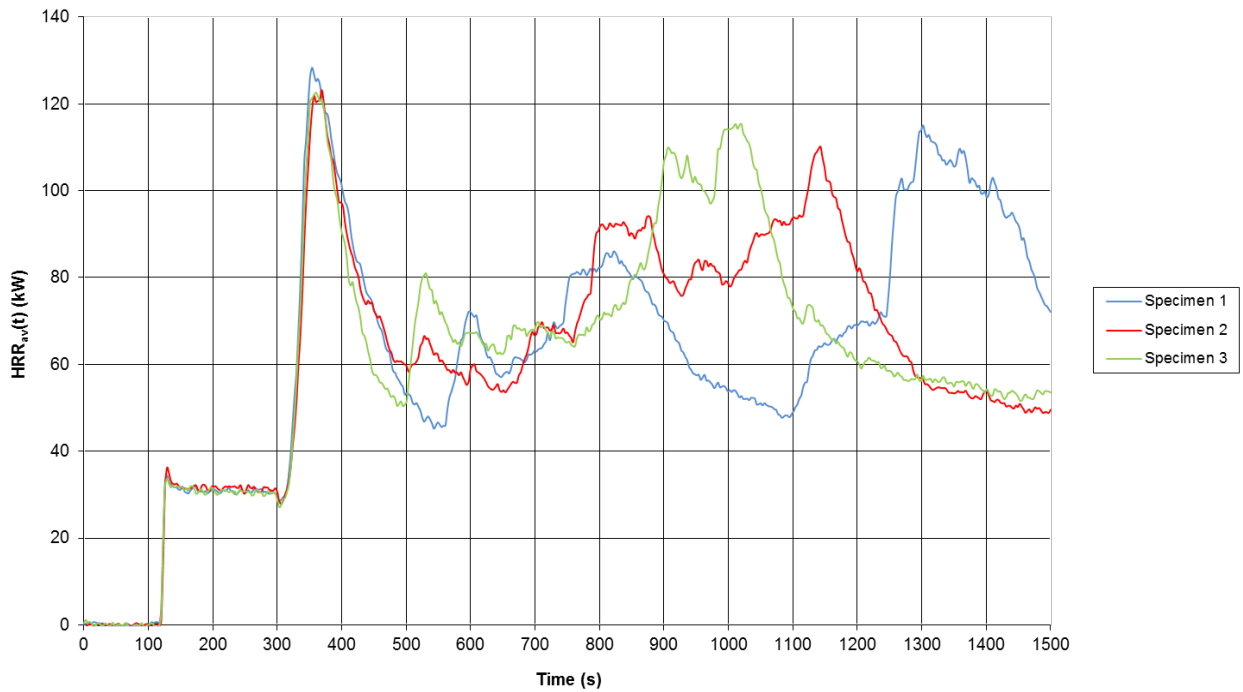
Figure 1. $HRR_{av}(t)$ (kW)

Curves of time averaged rate of heat release contribution of the specimen (HRRav(t)), cumulative heat release (THR(t)), and Fire Growth Rate (FIGRA) are appended as Figures 1 to 3. Curves of time averaged rate of smoke production (SPRav(t)), cumulative smoke production (TSP(t)) and smoke growth rate (SMOGRA) are appended as Figures 4 to 6 in appendix 2 of this report.

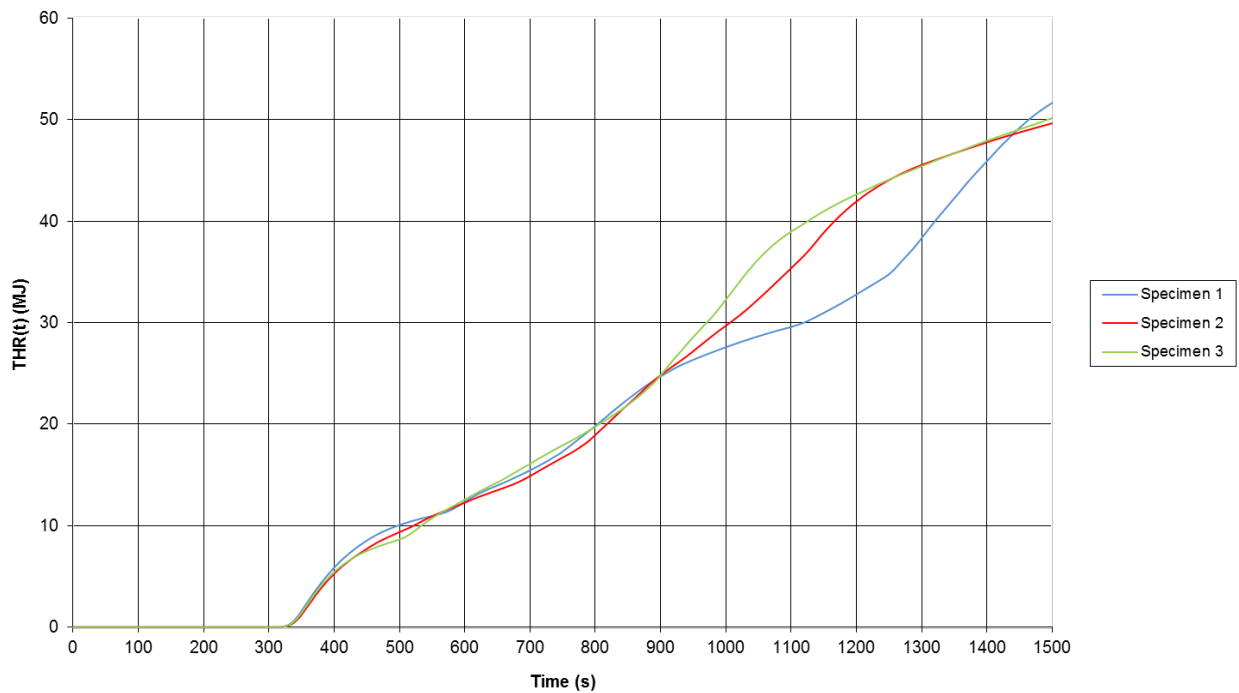
Figure 2. $THR(t)$ (MJ)

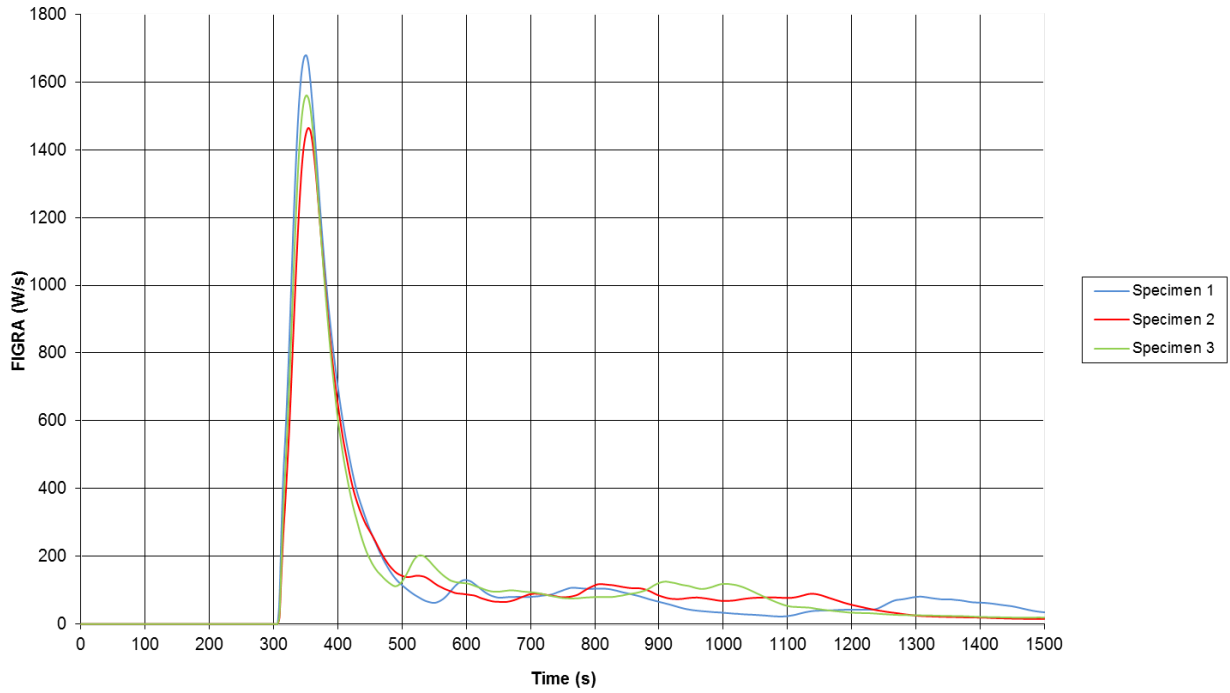
Figure 3. FIGRA

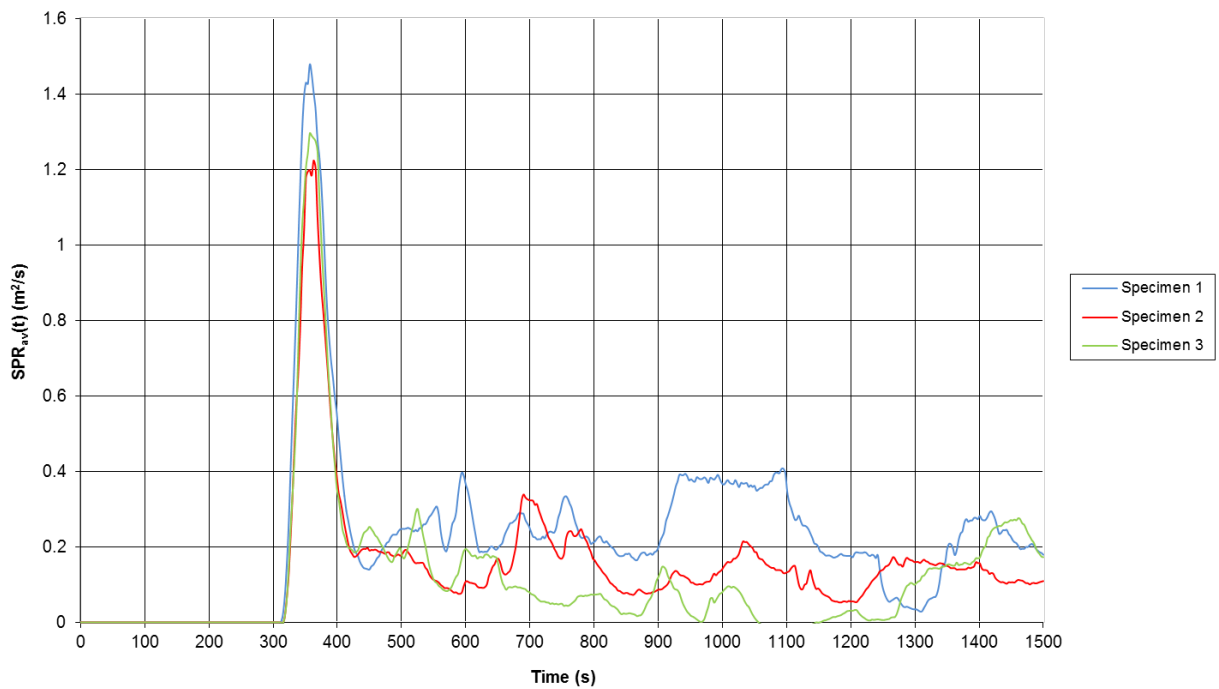
Figure 4. $SPR_{av}(t)$ (m^2/s)

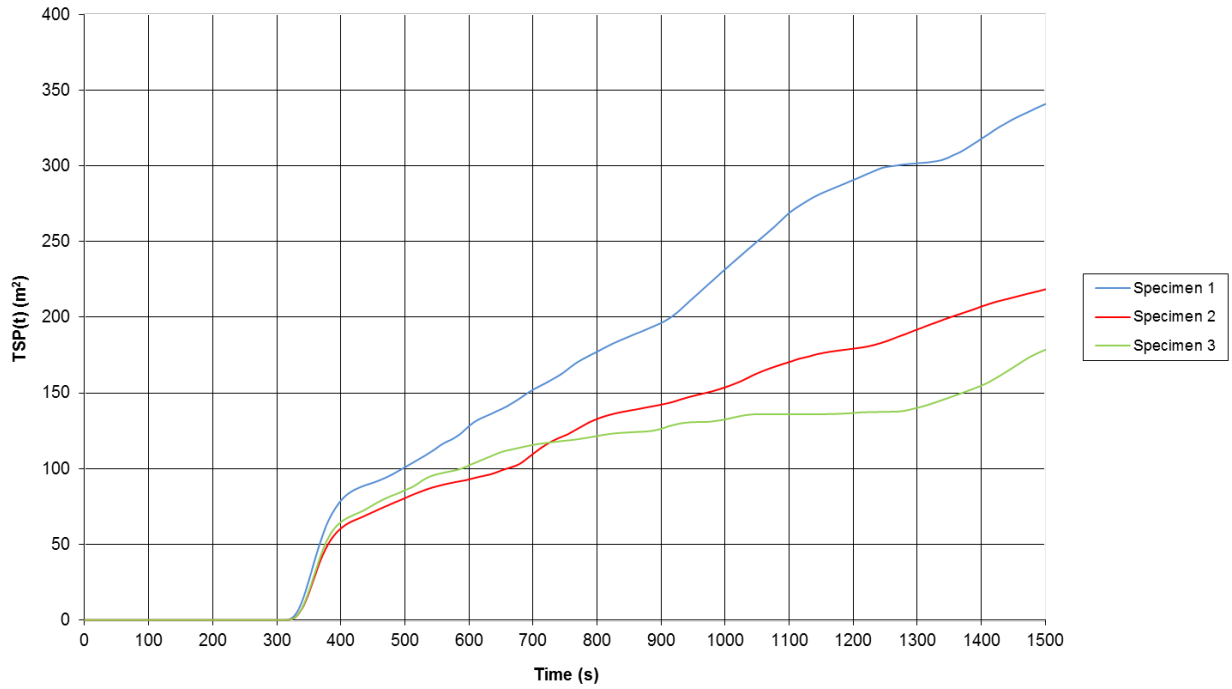
Figure 5. TSP(t) (m²)

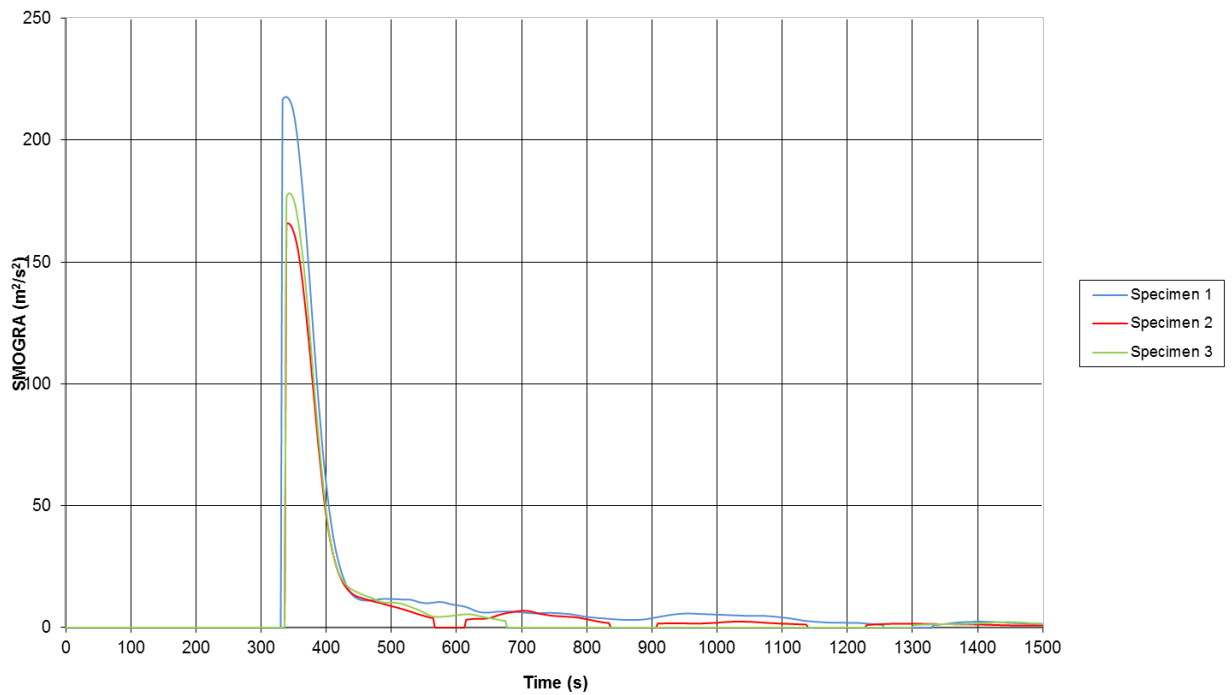
Figure 6. SMOGRA Graph.
